### DRAINAGE INVESTIGATION

The West Koke Mill HOA tasked Martin Engineering Company to investigate drainage issues and provide recommendations for solutions based on their findings. MEC also reached out to the City of Springfield with hopes they could provide "AS-BUILT" subdivision plans to verify the drainage system was constructed according to plan. Unfortunately, the City was unable to locate these documents and could only provide the generic preliminary plan. MEC generated surface contours using USGS Lidar data to compare the general drainage pattern of the subdivision with the preliminary plan. MEC also utilized GPS equipment to gather elevation data along key flow paths to verify these features were constructed with adequate slopes to promote positive drainage. The information provided below summarizes issues and provides recommendations for solutions at each respective location. **Refer to the attached Drainage Exhibits as they correlate aerial mapping and photo's ID locations to information herein.**

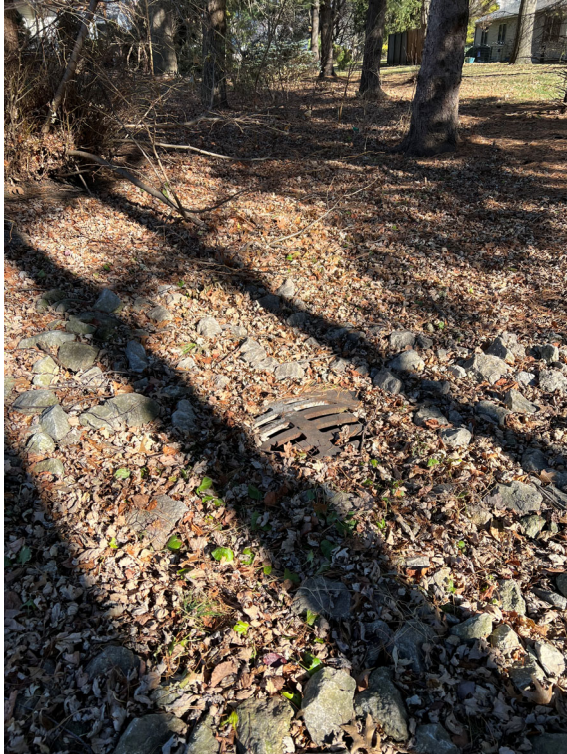
Photo 12:

The issue here relates to a clogged black 12" diameter corrugated plastic pipe (CPP) located within a 35' wide common area in the rear lots between Blueberry Lane and Clara Mae Court. At the time of investigation, the area inlet at the upstream end of the pipe section was full of water and the CPP was completely submerged, which suggest the pipe has an obstruction(s) preventing flow. During heavy rainfalls it is likely that the upstream drainage structure will surcharge, and pools of water will accumulate within this area. It is also likely that the homes adjacent to this area have gutter drains and/or sump pumps connected into this pipe, which will likely result in backups resulting in potential interior and exterior water damage.

Upstream drainage structure with CPP submerged in water.

1. Hire a licensed plumbing contractor to jet the pipe clear of debris such as leaves or trash. If an impassable obstruction is encountered, the plumbing contractor can utilize a sewer camera to investigate the location and type of obstruction (ex. tree roots). The camera video will also show the location of any residential gutter or sump drains that may be connected. If successful, this method would be the least impactful and most cost-effective solution.

- a. Estimated cost of plumbing service for jetting and camera 265 linear feet ~**\$2,000-\$3,000.**
2. Excavating, and replacing the portion(s) of the obstructed pipe would be the next solution if jetting is unsuccessful. This solution would be more impactful and could damage trees and landscaping located within the 35' corridor. Get an engineer's opinion on the extent of necessary repair and hire a licensed plumbing contractor address the issue.

- a. Estimated cost of removing obstruction and replacing damaged sections of pipe ~**\$2,000-**

**\$10,000.** Does not include tree removal if necessary.

3. Complete replacement of system. This would be most impactful and costly solution. Hire a licensed Engineer to draft a plan and assist in project administration/bidding.
  - a. Estimated cost for replacement of drainage structure and 265' of storm sewer. ~**\$20,000-\$40,000.**

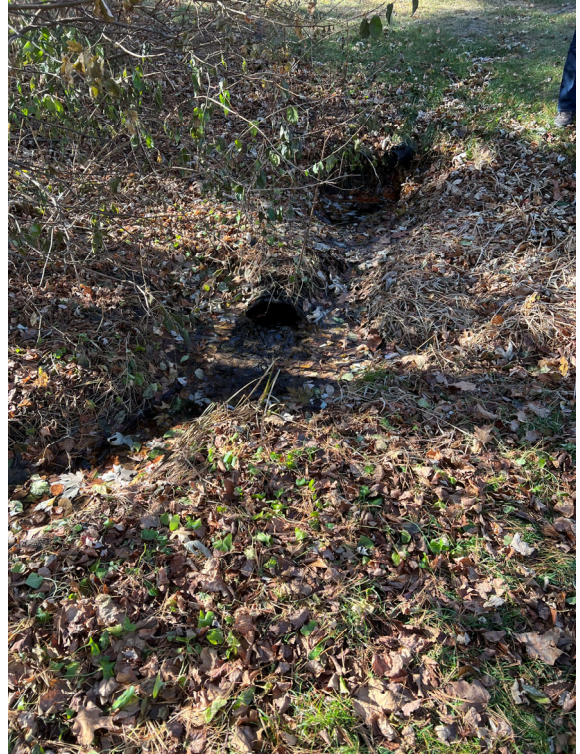
Photo 11:

Downstream outlet of clogged 12" CPP. Pipe outlets to Problem Area 1B.

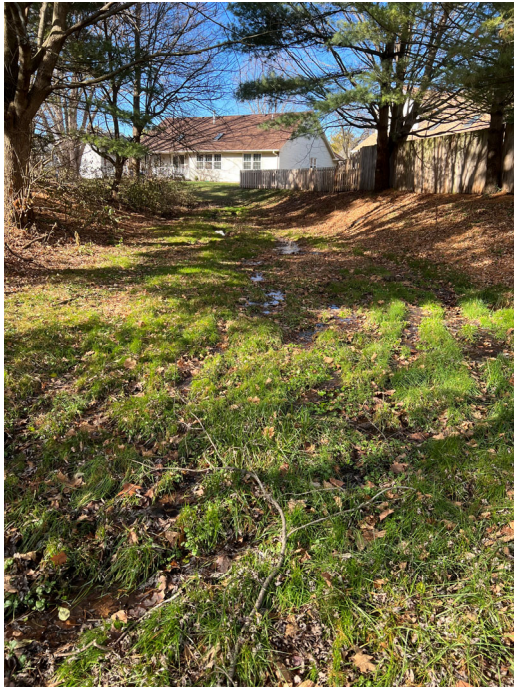
Photo 10:

This area holds pools of water for long periods of time making mowing and general maintenance difficult. Ideally, this water should flow from outlet pipe in Photo 11, at a consistent grade to the Koke Mill Rd ditch. It appears that over time, vegetation, and tree growth have altered the intended flow path trapping water in multiple locations throughout this detention area. Elevation data was gathered using GPS equipment to verify grades and explore solutions. The data found that there is approximately 1' of grade difference (~0.35% slope) between the outlet pipe and the roadway ditch. This grade difference suggests that minor grading along the intended flow path could solve this drainage issue.

Pooled water unable to drain to roadway ditch.

1. Hire a skilled operator capable of excavating at a precise grade along the flow path from the outlet pipe to the ditch. Excess soil from the high areas can be used to fill low areas to eliminate pooling water and promote positive drainage throughout the area. The swale alignment can be constructed to avoid damage or removing existing trees. Yearly maintenance of swale would be necessary to sustain positive drainage. Engineering construction guidance recommended.
  - a. Estimated cost of grading and constructing a vegetated swale ~\$3,000-\$8,000.
  - b. Estimated cost of grading and constructing a paved swale ~\$15,000-\$25,000. (Engineer recommends paved swales on slopes less than 1%).

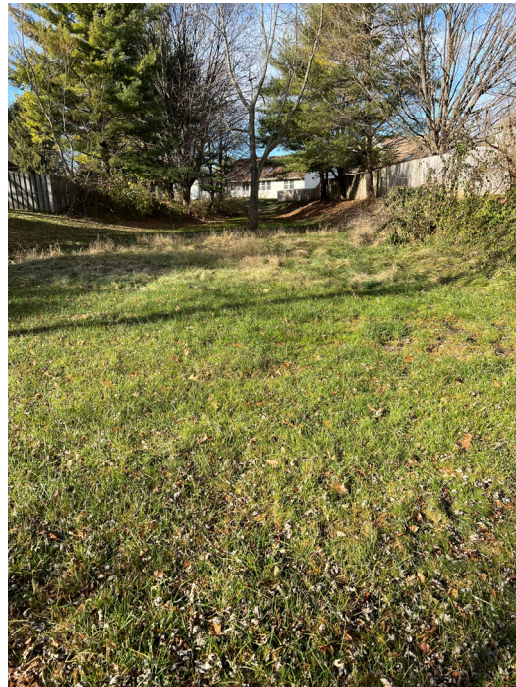
Photo 9:

Soil from high areas can be used to fill various low areas.

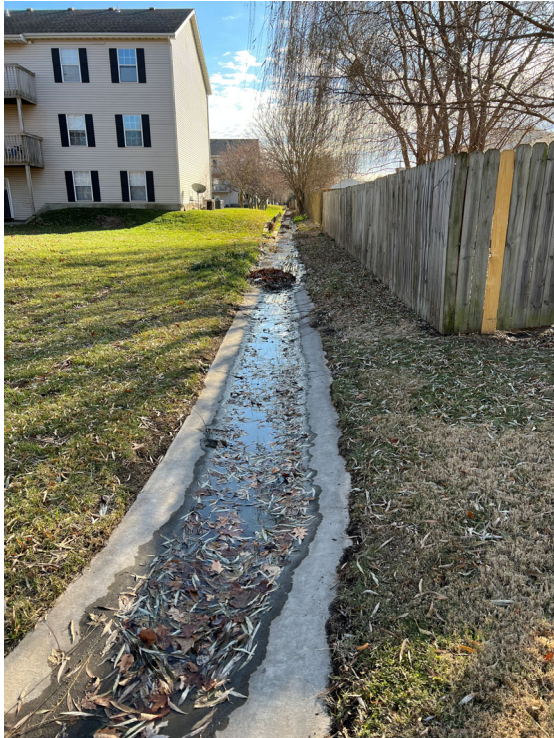
Photo 21:

This concrete drainage swale is located within a 20' wide utility easement spanning north-south along the west property line of Joplin Apartments. This swale collects stormwater from both the apartment complex and Checkerberry Lane. The northern 1/3 of the swale conveys water to the north @ ~0.3% slope toward HOA owned property and the southern 2/3 conveys water south @ ~0.2% slope towards Devils Walkingstick Drive. Much of this swale is cluttered with leaves, mud, and other debris which prevent flow and provide unpleasant scenery for nearby residents.

Leaf buildup at the northern portion of the drainage swale.

1. Yearly maintenance to remove built up debris. This work could be hired out or included in a voluntary subdivision maintenance initiative.
  - a. Estimated cost of debris removal ~\$0-\$1,500.

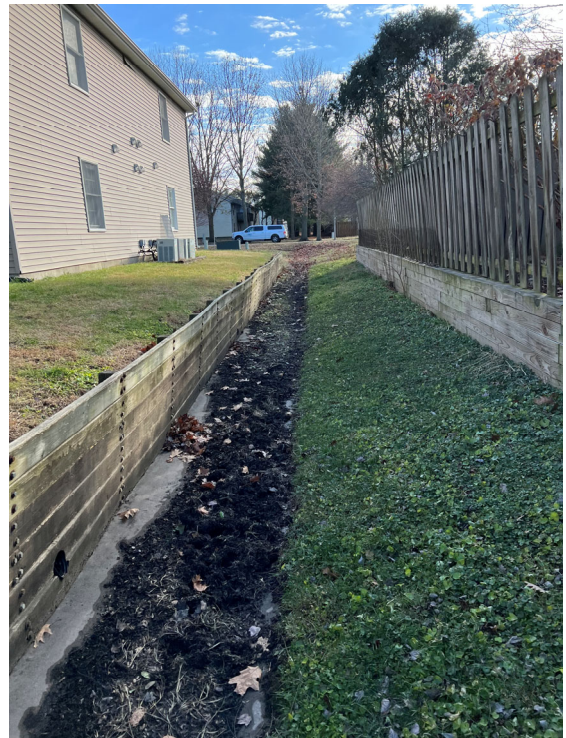
Photo 30:

Leaf & mud buildup at the southern portion of the drainage swale.

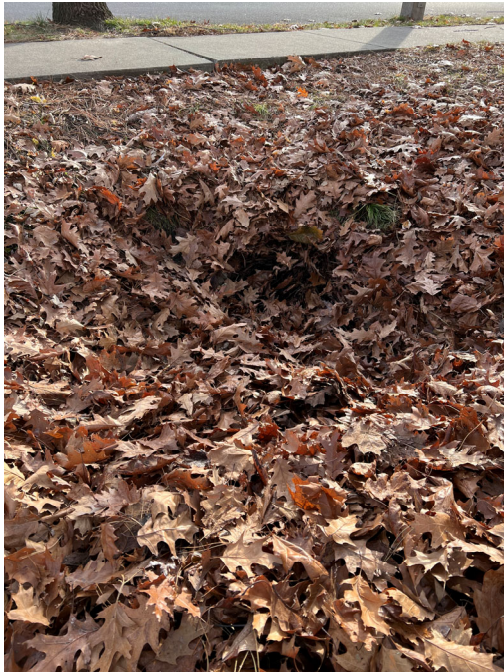
Photo 1:

12" concrete pipe @ Smyth Dr clogged with leaves causing water backup and long-term ponding.

- MEC discussed clogged pipe issue in Problem Area 2B @ Smyth Rd with a City of Springfield Public Works engineer. The representative added that they are aware of a storm manhole problem approximately 200' downstream that is likely contributing the drainage issues on HOA and Joplin Apartment property. Public Works intends to address this issue in the 2023 construction season.

1. Yearly maintenance to remove leaves and jet out clogged pipes. This work could be hired out or included in a voluntary subdivision maintenance initiative.
  - a. Estimated cost of debris removal ~\$0-\$1,500.
2. Coordinate with City Public Works Department for maintenance of 12" concrete pipe @ Smyth Dr. Even though this pipe is technically part of the city sewer system, they would like to see efforts made from the owners upstream to minimize leaves and debris reporting to their system (per phone conversation with Public Works Engineer on 12-22-2022). Installing a grate on the end of the pipe (photo #1) to catch leaves and debris to prevent interior blockage would be a suggestion.

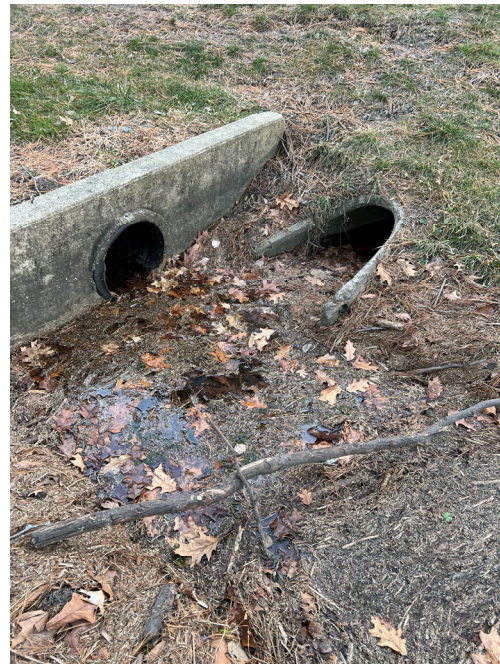
Photo 3:

This portion of the drainage detention system collects storm water from an approximate 10 acre watershed. This entire watershed reports to a 12" corrugated plastic pipe (CPP) located within Lot 4 of the Joplin Apartments which is designated for stormwater detention. This pipe often gets clogged with contributing leaves and debris from this watershed area. During large rain events, water is unable to pass resulting in water to backup and pond within the upstream HOA owned detention area. According to the HOA, 2'-3' feet of water can accumulate threatening homes adjacent to this common area. Once with water rises to a level that overtakes the concrete headwall for the CPP, water will flow overland to a 12" concrete pipe located on the west side of Smyth Drive. During the field investigation, this 12" concrete pipe was completely buried and clogged with leaves. At times when either of these 12" pipes area clogged, the detention system will cause unintended ponding upstream.

12" CPP with concrete headwall. Pipe recently cleared of debris according to HOA.

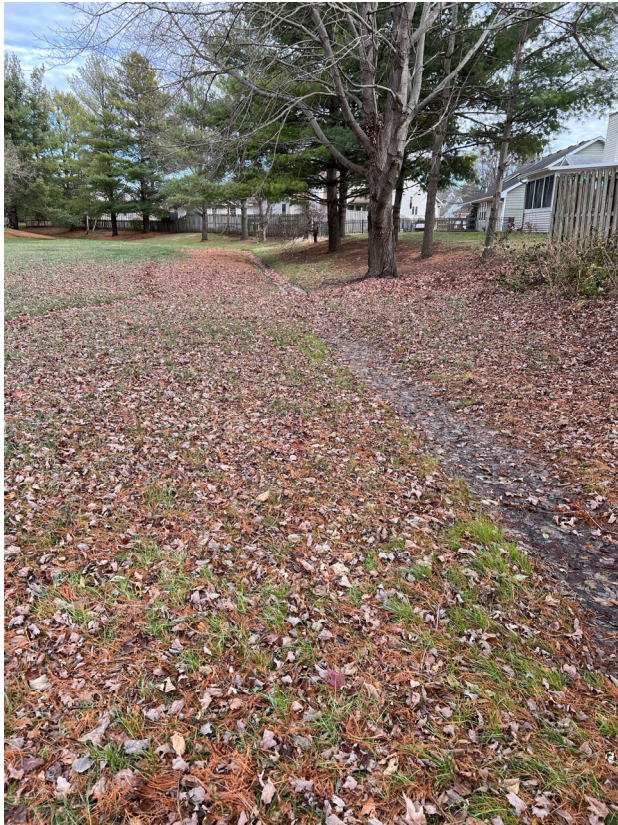
Photo 36:

This drainage area encompasses the common areas adjacent to the rear lots on Elderberry Ln, Raspberry Ct, and Blueberry Lanes. Concrete swales along the perimeters of this lots convey storm water to a 24" diameter concrete pipe from the west side of Elderberry Lane and outlets into the S Koke Mill Rd ditch. During field survey, GPS data was gathered along the concrete swales to verify slopes were adequate to promote positive drainage. Aside from leaf buildup within the concrete swales, no other issues were apparent at the time of survey.

Leaf buildup within concrete swales throughout drainage area #3.

1. Yearly maintenance to remove built up debris. This work could be hired out or included in a voluntary subdivision maintenance initiative.
  - a. Estimated cost of debris removal ~\$0-\$1,500.

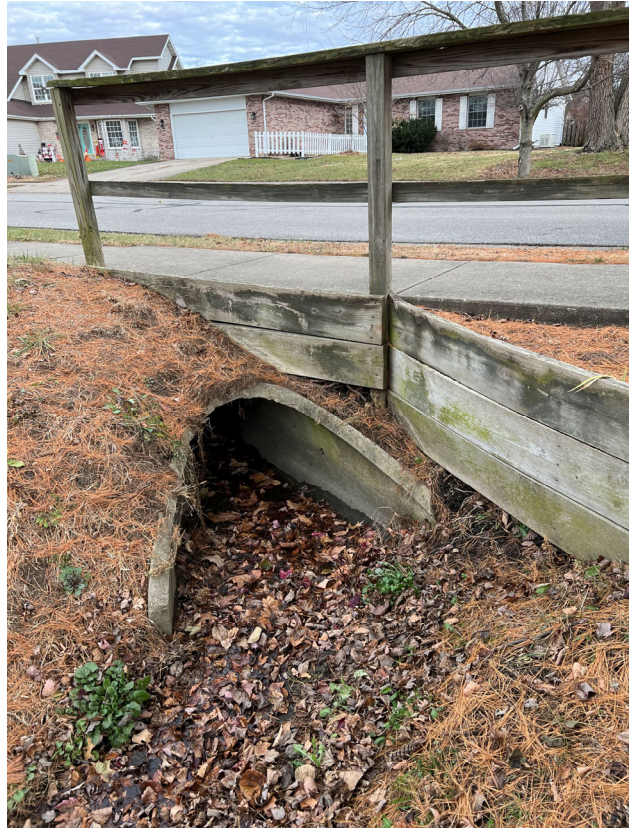
Photo 46:

Drainage area #3 reports to 24" concrete pipe @ Elderberry Lane. Leaf buildup apparent.
